Safety Alert – Viton O-rings

Issued by the Brutus Recovery Team, SEPCo, New Orleans

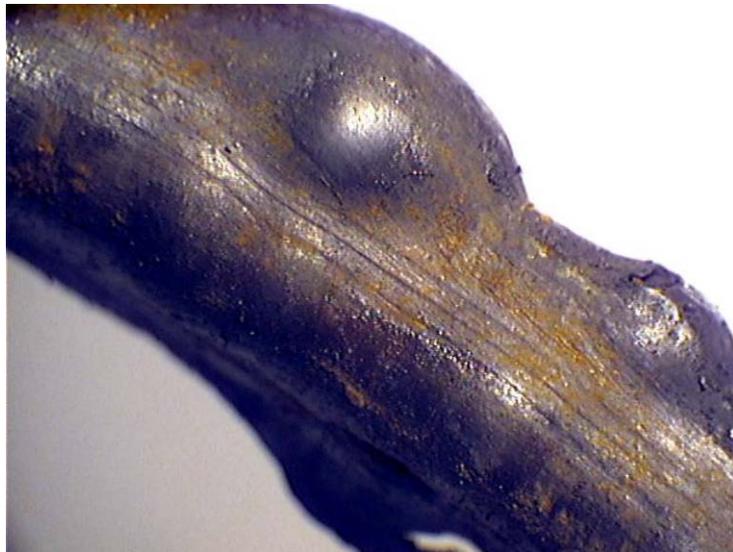
The Brutus TLP in the Gulf of Mexico took a controlled shutdown on 12th February 2002, following four observed gas leaks (3 very minor and one of 8 mcf) in similar circumstances, all from valves in HP & IP service (600 psi or greater). The failure mechanism would appear from the investigation to date to be explosive decompression of Viton elastomer o-ring seals (see figure below). Explosive decompression is a process in which gases that have been trapped within the given material are rapidly liberated and can cause seals to blister and fail. The Viton elastomer is commonly found in (but not limited to) ball valves, check valves, rotating equipment seals, and pressure safety valves. An investigation team has subsequently carried out a large inspection program all over the facility, inspecting more than 100 components. Over 70% of the Viton elements inspected are, in the opinion of the team, defective or questionable; suffering some degree of explosive decompression. The investigation team has concerns in the following areas:-

Of the elastomers inspected above, approximately 80% of those inspected were Viton GF in HP, IP or LP service (and 29% of which exhibited a high or moderate degree of ED). The remaining 20% were Viton A & B in HP or IP service (of which 54% exhibited a high or moderate degree of ED).

Figure 1: Failure Mechanism – Explosive Decompression

The investigation team has concluded that Viton GF is not explosive decompression resistant at certain operating pressures. It is recommended that your inventories are checked to ensure that Viton GF is not being inappropriately used in your operation. Please be additionally aware that the team's laboratory analysis to date demonstrates that some of the Viton GF used at Brutus exhibits hardness below the product specification range. In all circumstances, please satisfy yourself with respect to the quality of Viton products used.

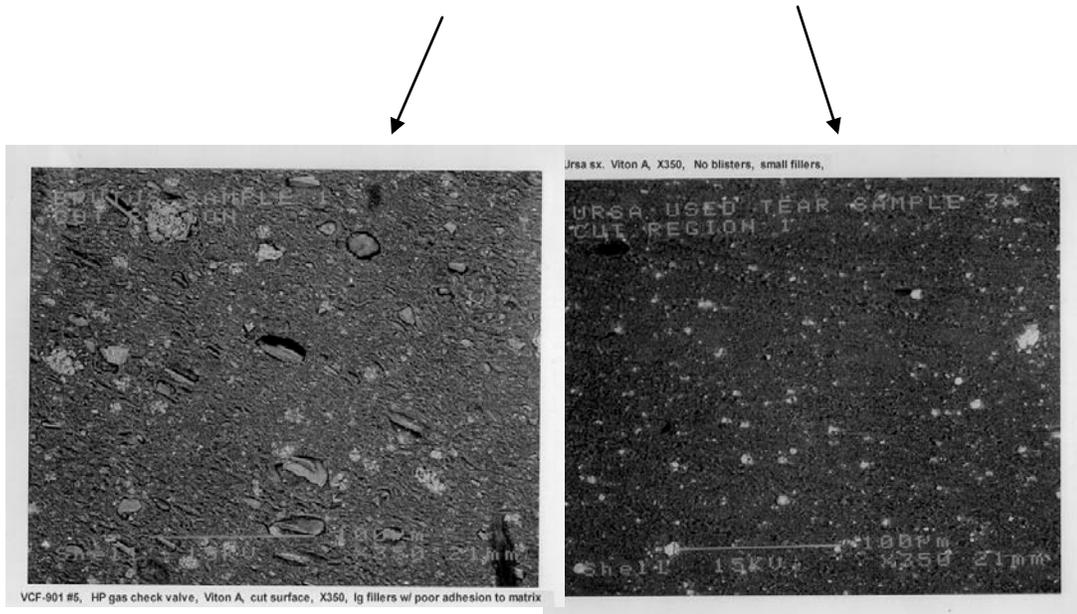
Viton A and B is widely used on SEPCo TLPs built prior to Brutus. There is evidence that some of the Viton A used at Brutus was less ED resistant than samples taken from a previously constructed TLP, Ursa. The following SEM photomicrographs show, for the Brutus sample, the existence of large filler inclusions which also appear to exhibit poor bonding to the elastomer matrix. The matrix itself is coarsely grained when compared to the used Ursa sample on the left. The used Brutus example exhibited ED, the used Ursa sample did not.

Figure 2: - Comparison of Brutus Viton-A & Ursa Viton A

It is recommended that your inventories are checked to ensure that Viton A & B is of the required quality and specification for your operation. This includes repairs that may have been carried out over the last 36 months.
